## ГРАДИТЕЉСКО НАСЛЕЂЕ КВАРТА КОТРОЧЕНИ: КАКО ГА САЧУВАТИ

**Marilena Negulescu**, PhD, Interior Architect, Lecturer  
U.A.U.I.M. (Ion Mincu University of Architecture and Urbanism), Bucharest, Romania  
mari.negulescu@gmail.com

**Dragos Negulescu**, PhD, Architect, Lecturer  
U.A.U.I.M. (Ion Mincu University of Architecture and Urbanism), Bucharest, Romania  
dragos.negulescu@gmail.com

## **BUILT HERITAGE OF COTROCENI NEIGHBOURHOOD: WAYS TO PRESERVE IT**

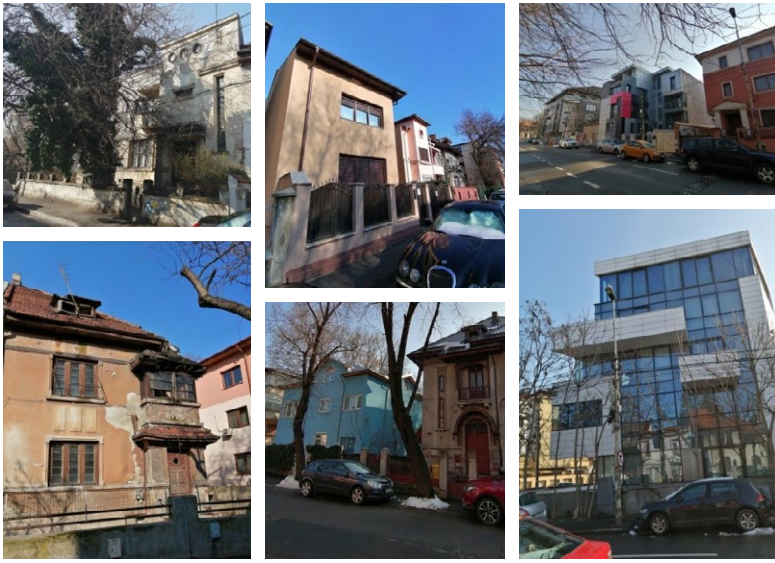
Figure 1. Categories 1, 2, and 3 (2021)

These buildings, in different stages of degradation, still reflect the history of the neighbourhood. Some buildings have kept their features made 100 years ago. We are talking about a beneficial contribution to the general image, especially due to the comparison of this category with the next two, which are really harmful to the homogeneity of the neighbourhood;<sup>13</sup> namely, buildings were renovated in a way that destroyed the original identity and, on the other hand, some both functionally and stylistically alien facilities were introduced.

The first category, that of worthless renovations, occurred mainly between 2000 and 2010, with the view to increasing the real estate value in the area.<sup>14</sup> Both few real owners and the investors from outside of the neighbourhood, used the loose legislation to increase the value of the property as a whole. We are talking here about two categories of aggression: the first, the most obvious one, refers to the treatment of the facing, which in most cases meant cladding the facade with well-known insulation-system (polystyrene and structured plaster); such interventions stripped the buildings of their moulding frames, resulting in approximations and interpretations of the original frames made from polyurethane rods. The rest of the details were affected as well, especially the fittings, with the original double-glazed wooden fittings being replaced with the PVC ones, with large areas of glass, unlike the original wrought-iron and steel windows. The roofs, mostly made of ceramic tiles, have been replaced with light metal roof coverings, without respecting, in some cases, even the stereotomy or colour of the original material.

Insertions that are alien to the place are not many, but due to the distorting effect, they are visually ubiquitous over large areas, disturbing the peace of a coherent street organisation. The lack of care for the integration into the built surroundings shows itself in the use of modern materials non-compliant to the surroundings – glass, metal, plywood, in the façade compositions that do not respect the masonry - openings ratio characteristic of load-bearing masonry architecture, and in the use of aggressive shapes and colours. Beyond these, perhaps the most harmful are the inserts made on another scale, those that do not respect the size of the area, both in height and in its base. These elements suffocate the surroundings, literally removing from the atmosphere of the neighbourhood their areas of visual and functional influence.

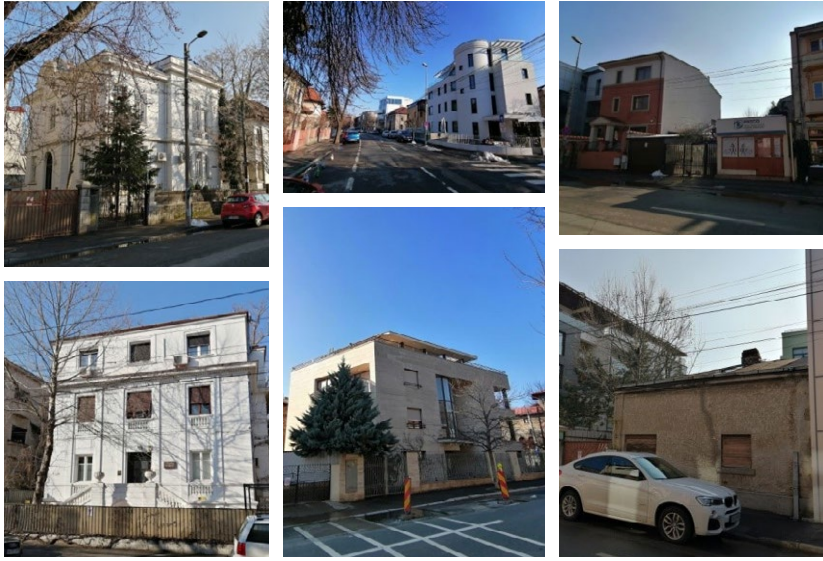
Figure 2. Categories 4, 5, and 6 (2021)

These organizations go beyond the social-community character and try to revitalise the area by organizing tours, periodic annual events, and exhibitions, as opposed to two negative categories presented above. Under the title “So (possibly) yes”, they struggle for the consolidation of buildings, but also for the correct restoration and inserts ranging from “do not adversely affect the context” to “are beneficial to the surroundings”. Regarding the restorations, it is encouraging that the most valuable buildings in the neighbourhood were restored thanks to the owners who see in it the possibility to gain personal recognition.

In another category, as in any architectural criticism, opinions can become subjective. However, we conclude that a new insertion, which respects the position on the lot in terms

Cotroceni houses can be put in the sixth category for two particular reasons. First, they are different type of buildings than the general interwar ones, and second, these houses constitute a potential curative fund for the area.
